Archipelagos Not Islands: Linking Resilience of Buildings with Infrastructure Lifelines

Municipal Perspective & Post Earthquake Evaluation Tools

Dane Doleman, P.Eng. ENV SP
Structures Engineer
Understanding Risk BC
April 17th, 2018

Post Earthquake Inspection Guide

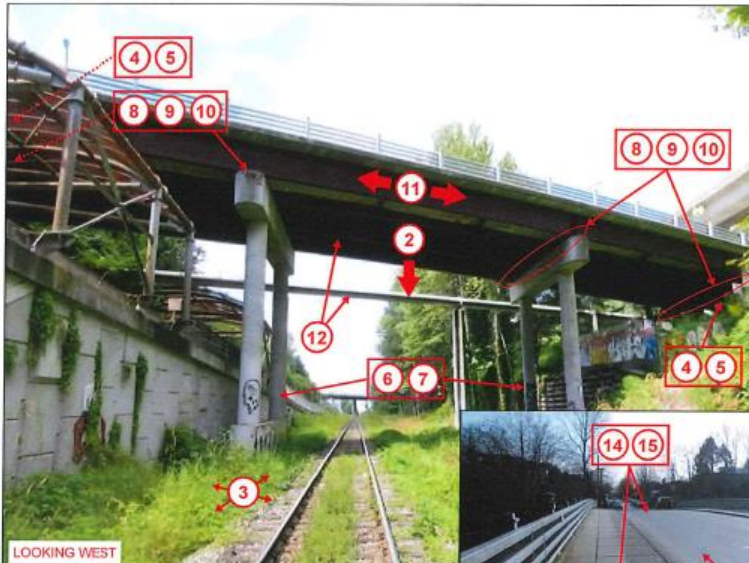
LOOKING WEST

BEST VIEWPOINT & ACCESS LOCATIONS

• If possible, the **best** **vertical** approach to the bridge is from the north end. This will provide optimal access to perform an assessment of the Skytrain flyover (see next bullet) and is the side with the only means of access down to the central piers.

• There is a **Skytrain (Expo Line) Flyover** crossing directly above the north end of the bridge. While not within the City's inventory its condition may necessitate the closure of the Woodland Drive Bridge.

• There is a **Water Main** pipe structure just west of the bridge. Appropriate caution should be exercised as the pipe may have ruptured during the EQ.

• Access to the **Abutments** is best achieved at the west side of the north abutment, and the east side of the south abutment (a type 12 key is required). Access to the bases of the piers is only possible from the north end of the bridge as the Millennium Skytrain cuts off access from the south.

• Misalignment in the **Train Tracks** below the structure is a strong indicator that soil displacement has occurred which can affect the stability of the abutments.

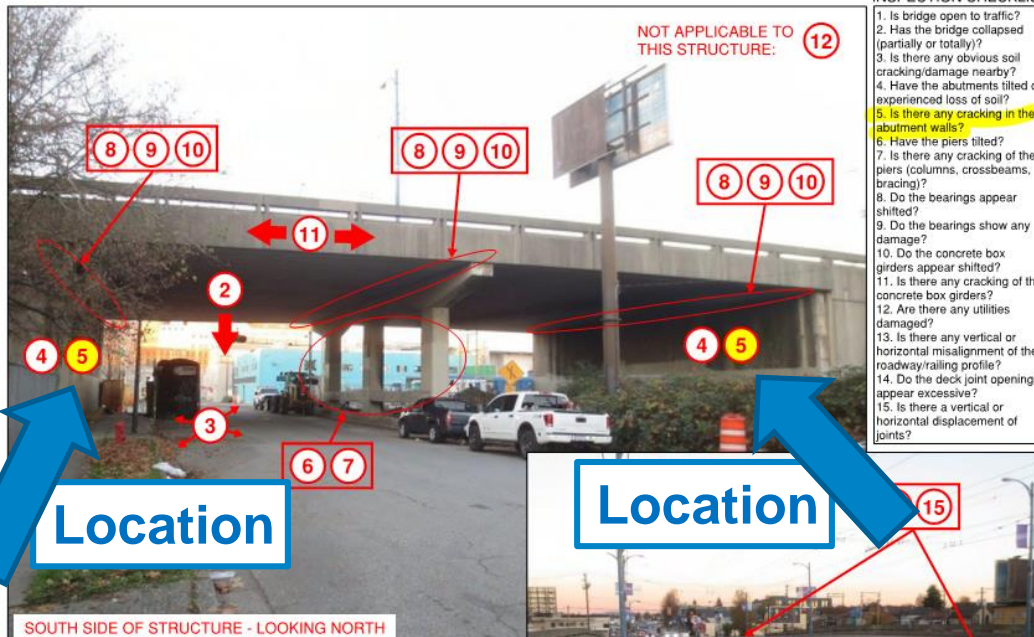
SOUTH SIDE OF STRUCTURE - LOOKING NORTH

BEST VIEWPOINT & ACCESS LOCATIONS

- There is no **Ideal Arrival** approach to the bridge as access to all ends/sides is made relatively easy using local side streets.
- In general, **Access Below the Structure** is best achieved by using the streets to the north of the structure as the route to the south is more extensive (over several blocks).
- The **Bearing Shelves** at both sides of the bridge and at the central pier are not easily accessible on foot. Proper access will require equipment not anticipated to be available for the Level 1 Inspection which can make assessment of these areas difficult.
- Misalignment in the **Train Tracks** below the east span of the structure is a strong indicator that soil displacement has occurred which can affect the stability of the abutments.
- **Access Key Not Required:** There are no locked gates restricting access at structure.

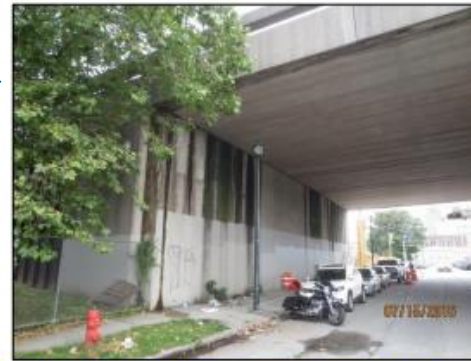
West abutment with stains from water leaks.

Review existing photos of actual abutments and pre-existing condition

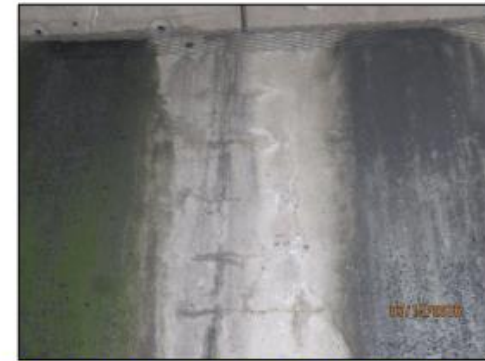
Existing vertical cracks in west abut concrete.

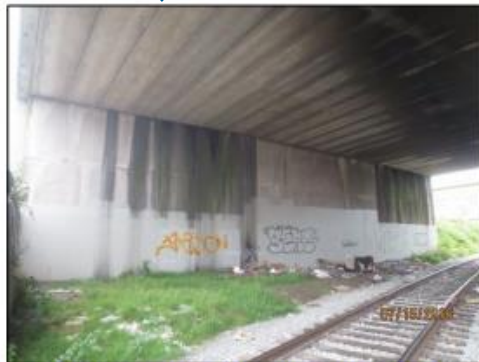
East abutment with stains from water leaks.

Sig. Diagonal Cracks are present at East Abutment

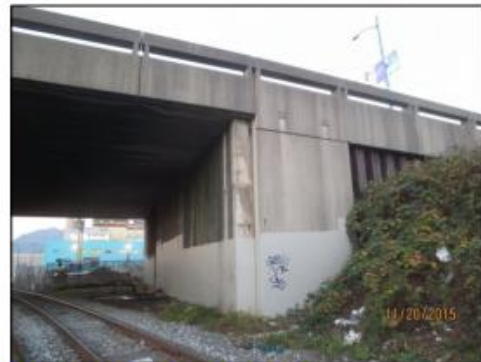
South corner of east abutment.

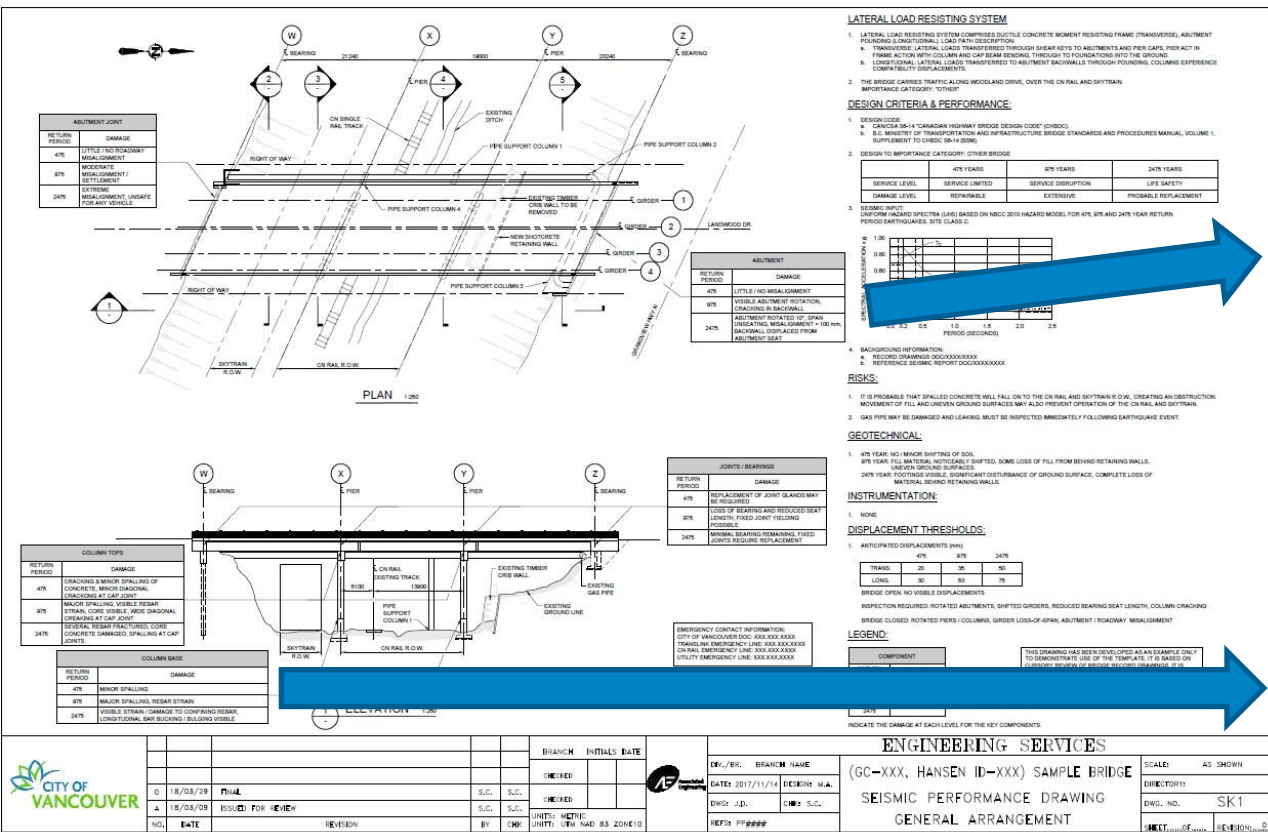
Seismic Performance Drawing Template

Abutment

Return Period	Damage
475	Little / no misalignment
975	Visible abutment rotation / cracking in backwall
2475	Abutment rotated 10deg, span unseating, misalignment > 100mm

Column Base

Return Period	Damage
475	Minor spalling
975	Major spalling , rebar strain
2475	Visible strain, damage to confining rebar, longitudinal bar buckling, bulging visible

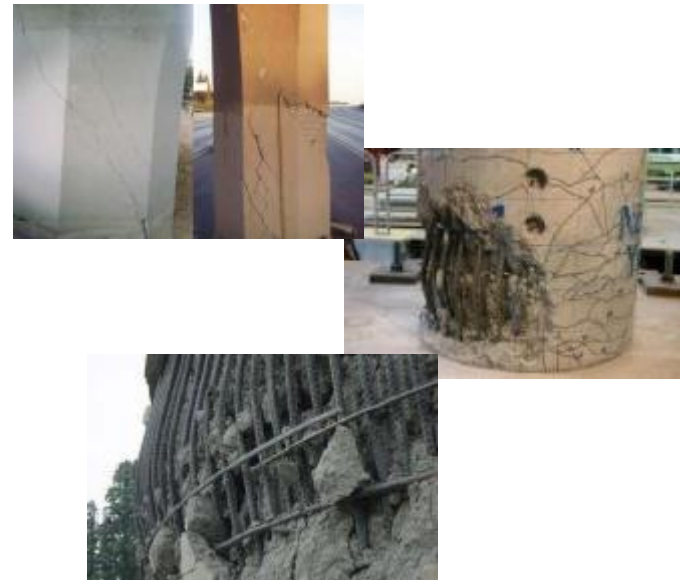
Column Base		
Return Period	Damage	Reference Photo
475	Minor spalling	C##1
975	Major spalling , rebar strain	C##2
2475	Visible strain, damage to confining rebar, longitudinal bar buckling, bulging visible	C##3

- Standardized photo library of typical damage states
- Guidance on what states indicate an open, closed or limited access structure
- Decision tree logic for specific damage states
