Implementing risk-based asset management strategies

The Challenge for Local Governments

Stormwater Asset Risk Assessment

A Profile of Earthquake Risk

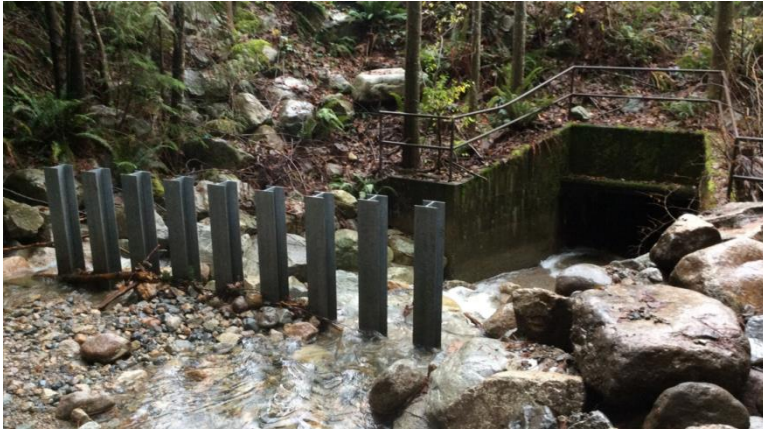
Debris Control Structures

risk control

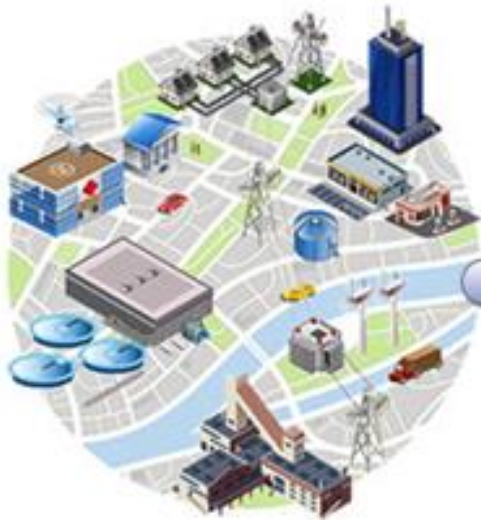
UBC Business Disruption and Loss Model

After Chang, S.E., et al., 2008: MCEER Technical Report

Built Environment

Vulnerability

Building Damage

Water Outage

Power Outage

Loss of Functionality

Probability of Closure

Neighborhood Effects

Loss of Business Revenue
